**Ideal Standard**

**Tesi**  
**A6556 .. A6562 ..**

0621 / A 868 721  
 Made in Germany

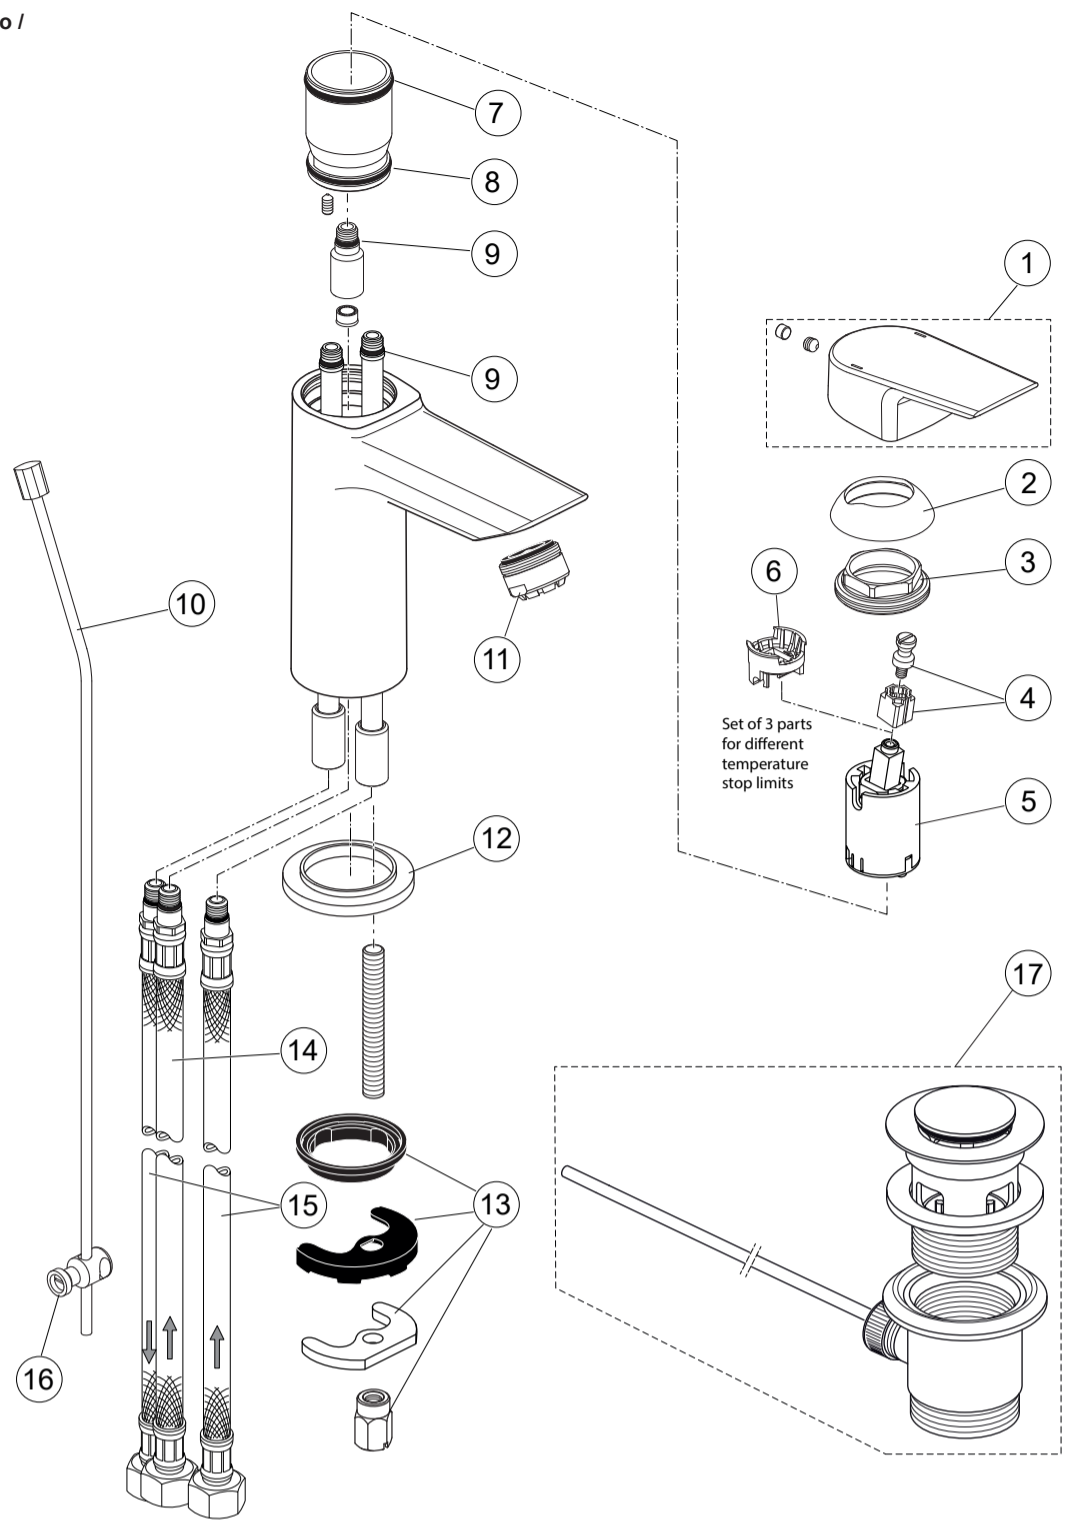
| Pos. | Part No. |

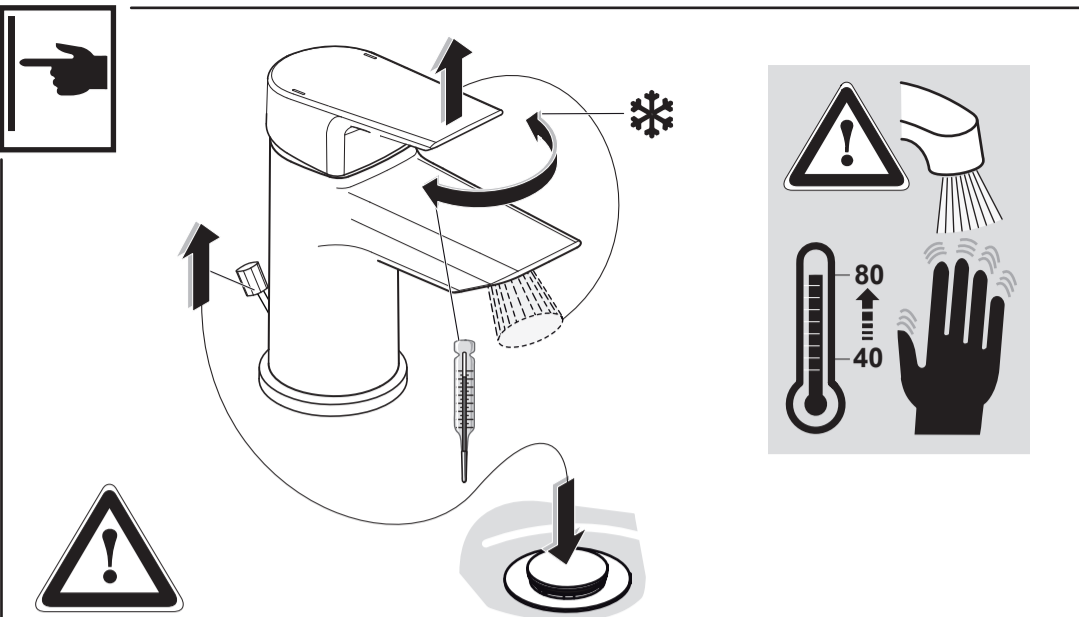
Es ist systembedingt, daß während der Aufheizzeit Wasser durch Ausdehnung am Auslauf abtropft. Dieser freie Austritt verhindert einen Druckanstieg im Speicher. Es darf deshalb niemals der Auslauf verschlossen werden. Der Einbau eines Luftsprudlers oder Schlauches mit Strahlregler ist nicht zulässig. Der im Batteriekörper eingebaute Durchflußbegrenzer macht die Armatur unabhängig vom vorhandenen Wasserdruck. Einregulieren der Wassermenge ist nicht erforderlich. Der Durchflußbegrenzer darf nicht entfernt werden!

As the water heats up, it will expand & possibly discharge through the outlet. This water discharge is normal to prevent pressure damage to the hot water vessel. DO NOT close this outlet. Aerator or hose with flow-straightener should not be used either. The built in flow limiter regulates the supply water pressure, therefore it is not necessary to use other regulating devices to control the flow. DO NOT remove the flow limiter!
